**SITE ASSESSMENT REPORT
FOR
TILTON PLATING
TILTON, VERMILION COUNTY, ILLINOIS
TDD No.: S05-9809-012
PAN: 8P1201SIXX**

December 1, 1998

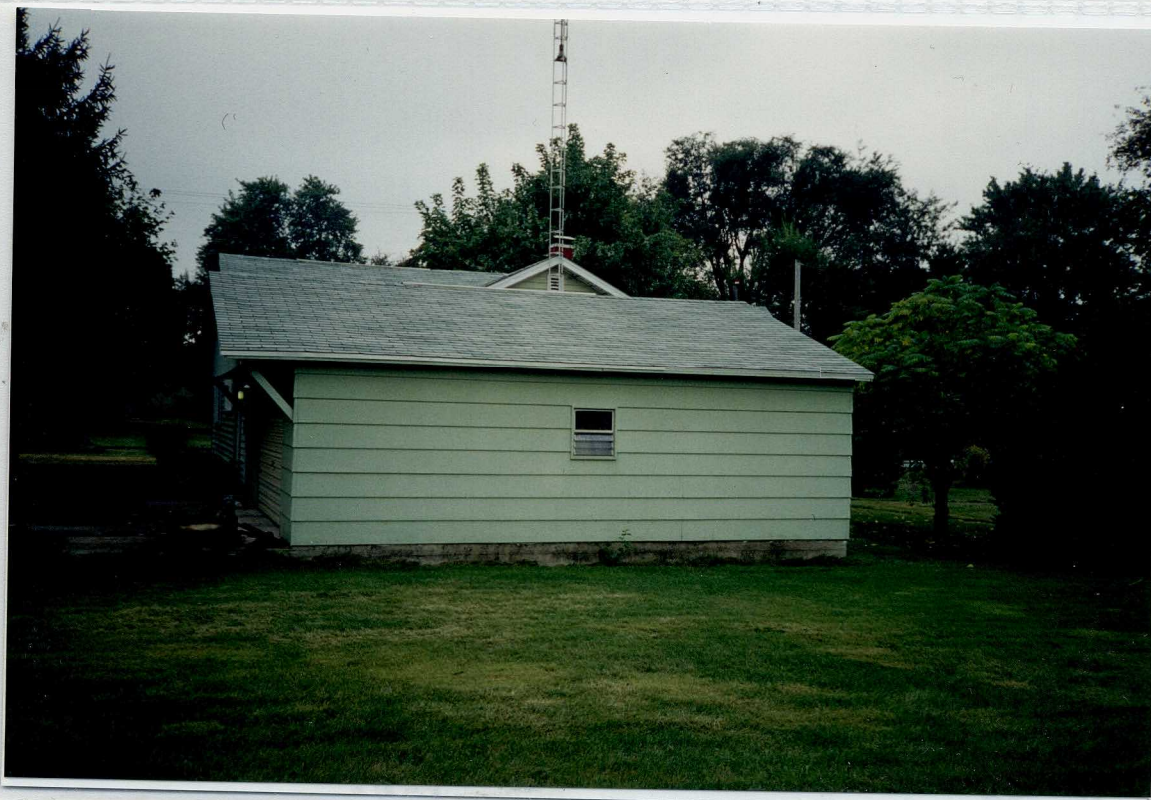
SITE: Tilton Plating **DATE:** September 25, 1998 **TIME:** 1045
LOCATION: Tilton, Illinois **DIRECTION:** South **PHOTOGRAPHER:** Bill Sass
SUBJECT: Residence located south of Tilton Plating, viewed from the driveway of the site.

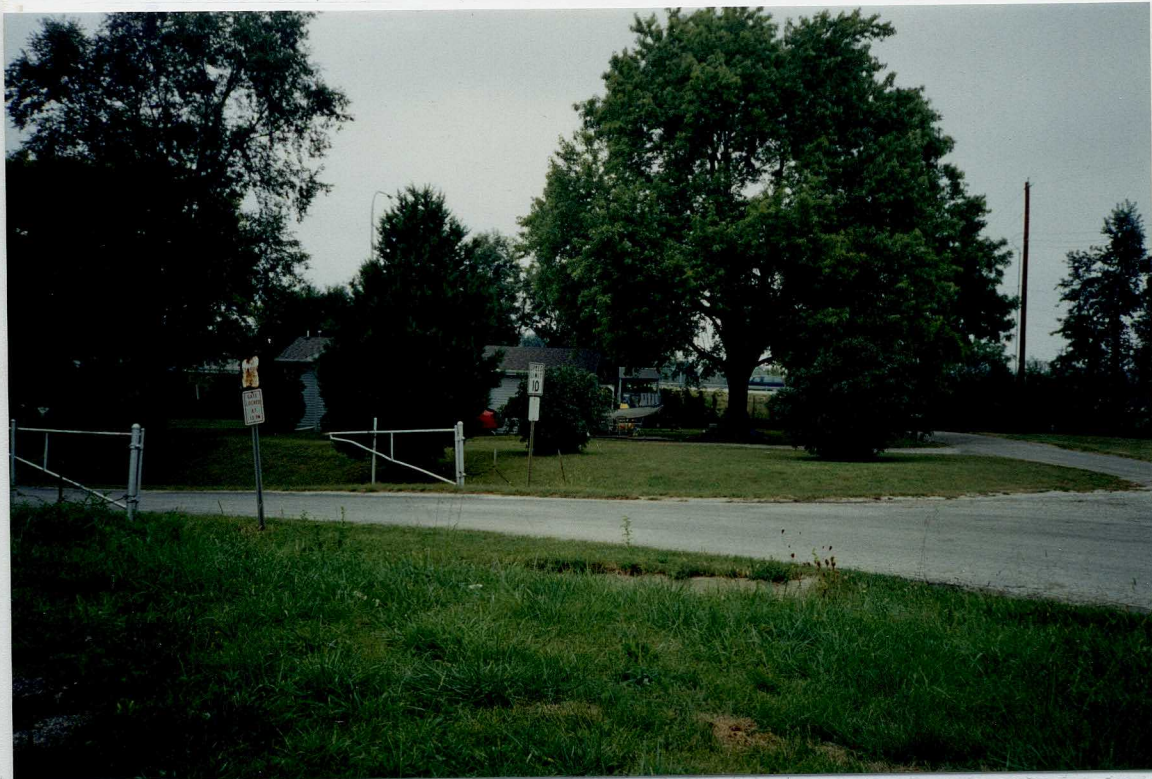
SITE: Tilton Plating **DATE:** September 25, 1998 **TIME:** 1045
LOCATION: Tilton, Illinois **DIRECTION:** North **PHOTOGRAPHER:** Bill Sass
SUBJECT: Residence located across Fairfield Street north of the site, viewed from the driveway of the site.

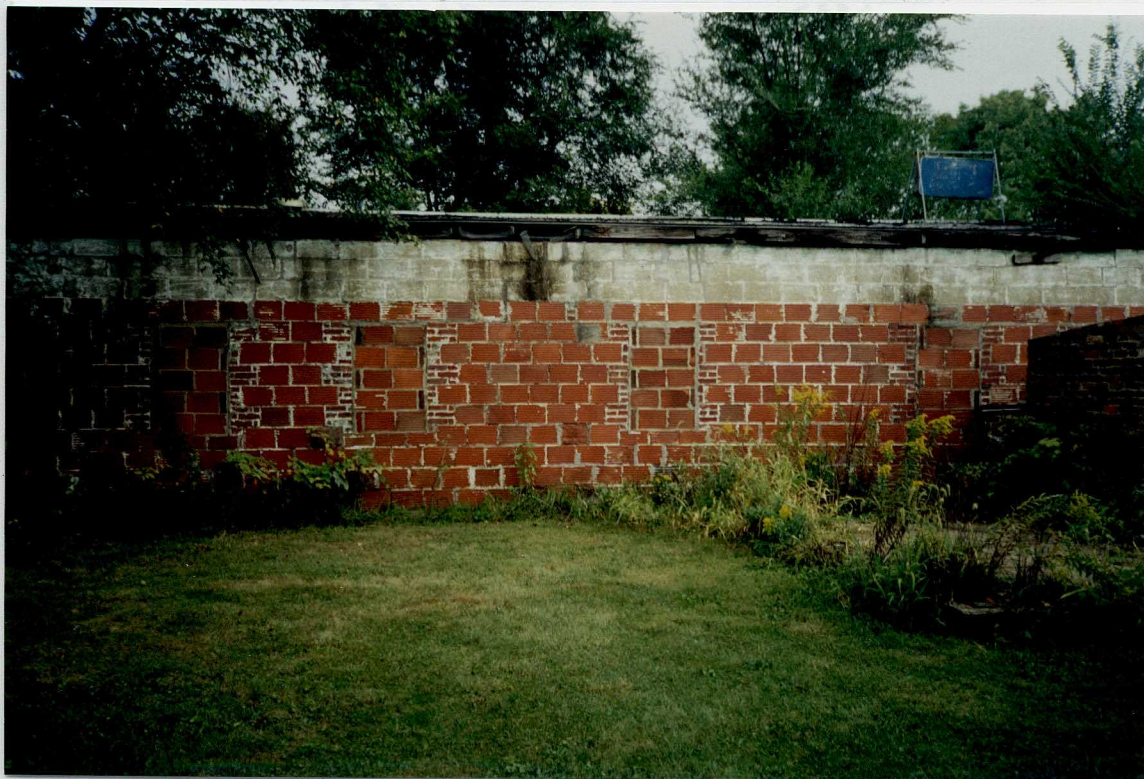
SITE: Tilton Plating DATE: September 25, 1998
 LOCATION: Tilton, Illinois DIRECTION: North
 SUBJECT: South wall of building.

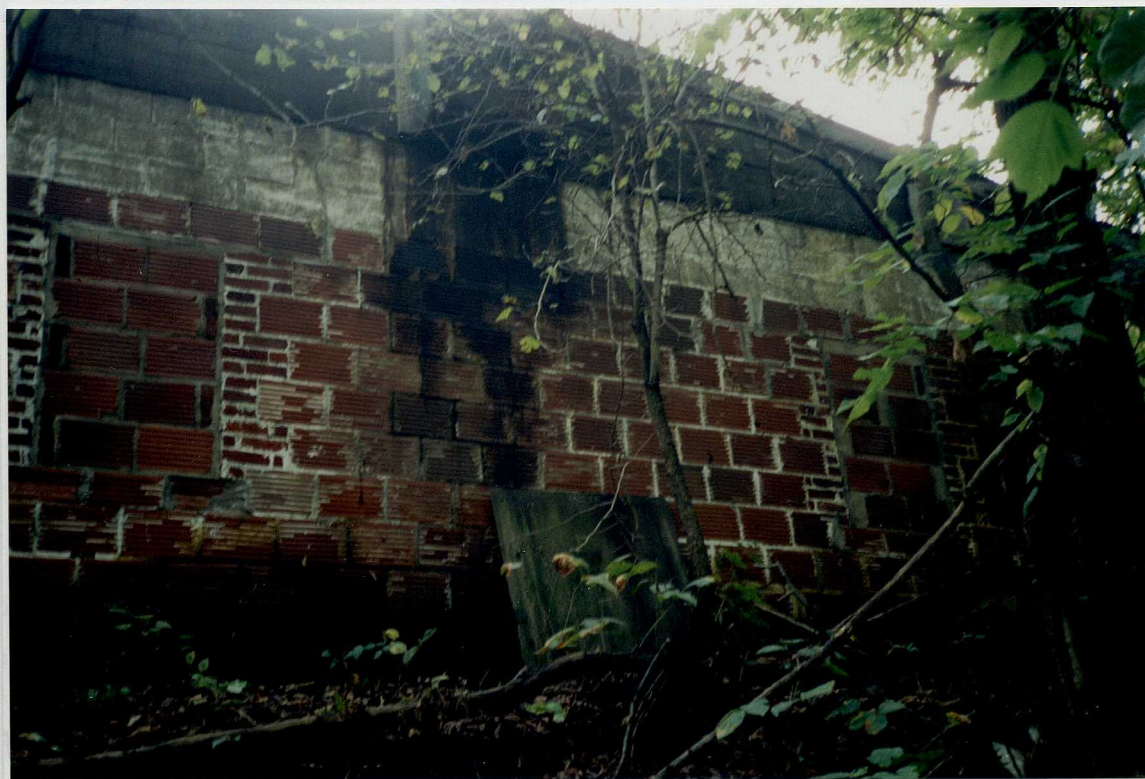
SITE: Tilton Plating DATE: September 25, 1998
 LOCATION: Tilton, Illinois DIRECTION: East
 SUBJECT: West wall of building.

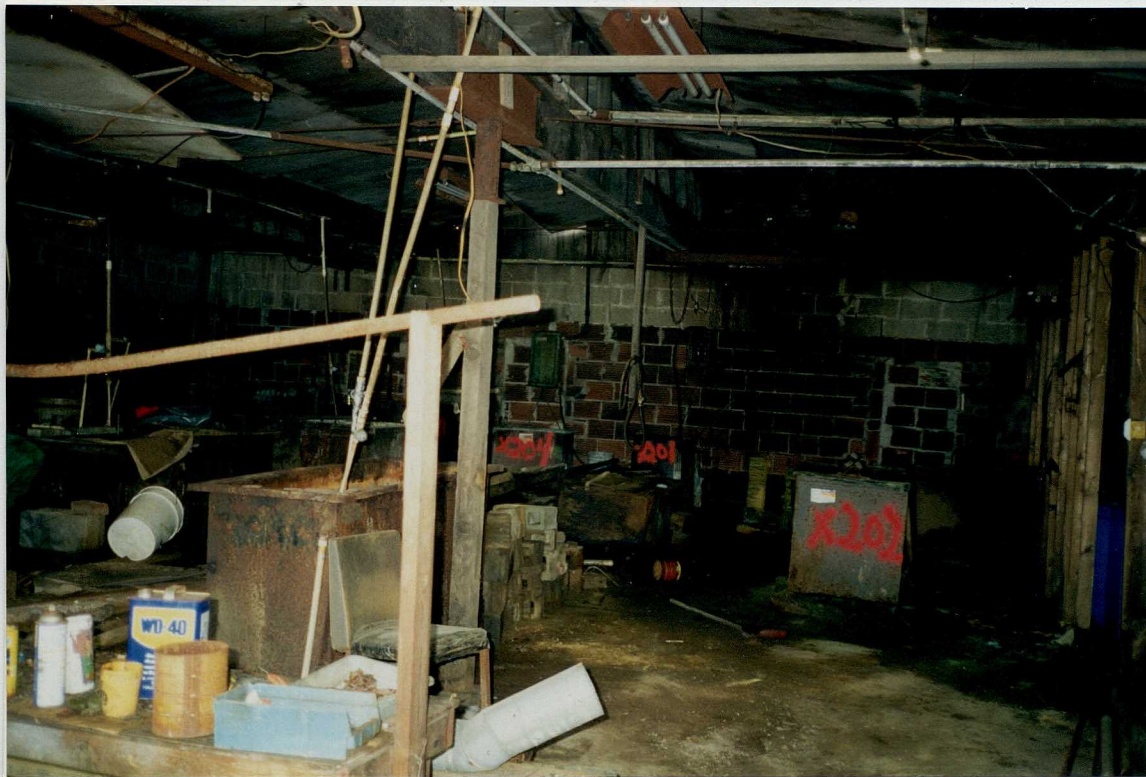
SITE: Tilton Plating DATE: September 26, 1998 TIME: 0930
 LOCATION: Tilton, Illinois DIRECTION: West PHOTOGRAPHER: P. Atkociunas
 SUBJECT: View inside plating shop.

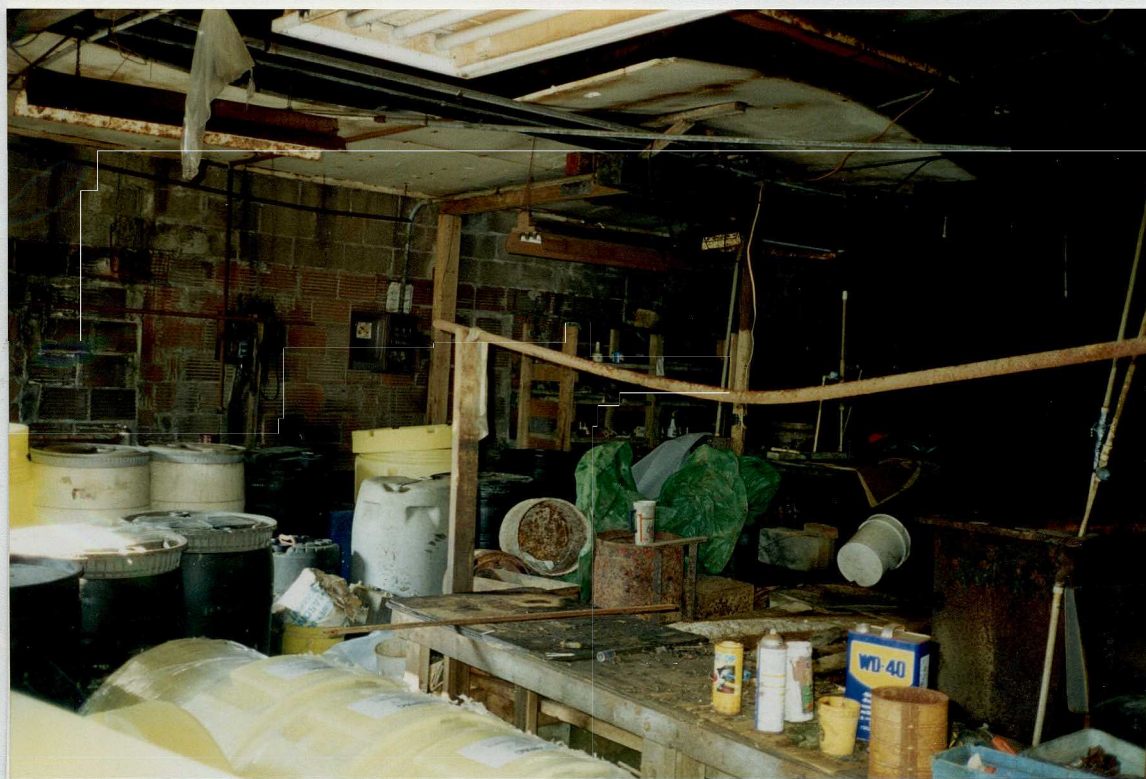
SITE: Tilton Plating DATE: September 26, 1998 TIME: 0930
 LOCATION: Tilton, Illinois DIRECTION: Southwest PHOTOGRAPHER: P. Atkociunas
 SUBJECT: Inside building.

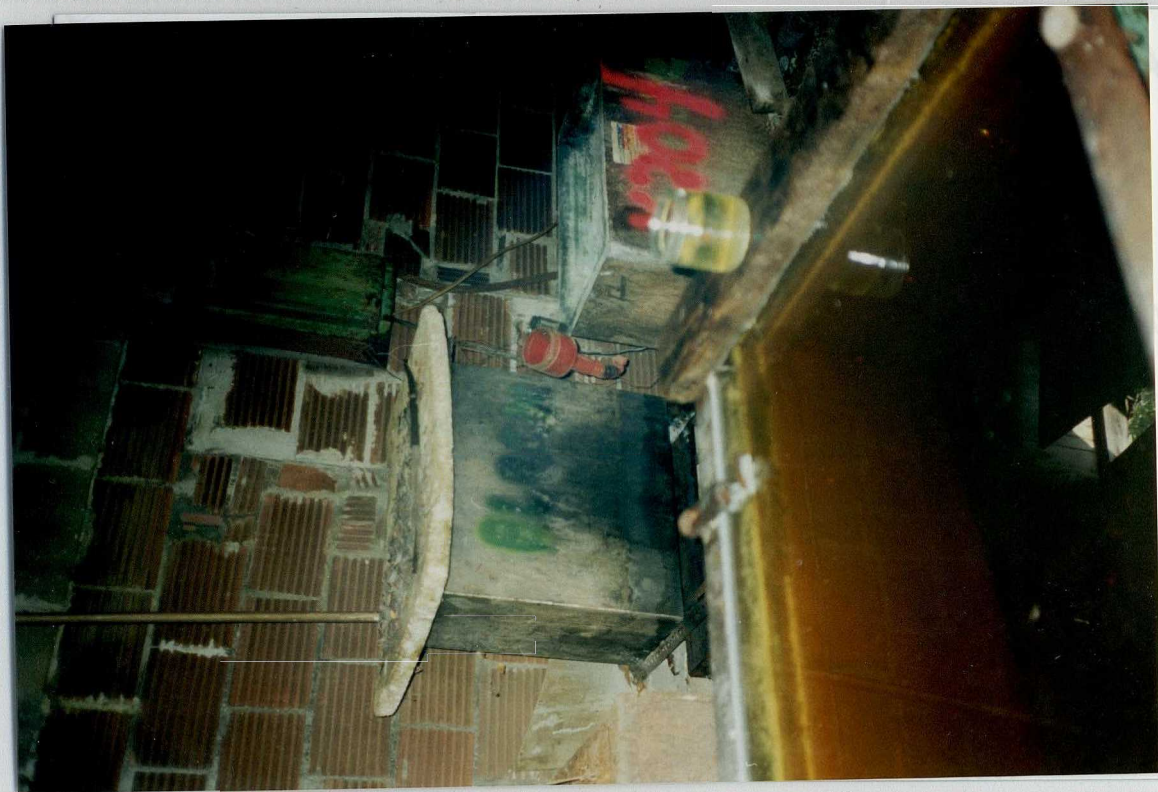
SITE: Tilton Plating
LOCATION: Tilton, Illinois
SUBJECT: Vats.
